ATA 36

Engine bleed air system

Patrick Grave
Pneumatics, Ice and Fire Protection
Customer Services Engineering

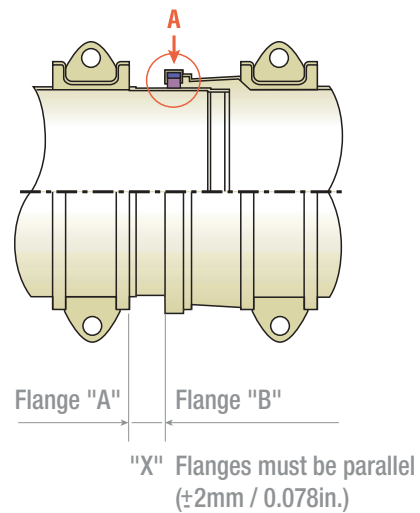
Bleed air duct seal installation

Typical installation

The second solution offers a far greater service life and is considered the final fix. It incorporates a new design of bleed air duct seal, ABS1040, and is available through SB A320-36-1043 (Modification 32027, Embodiment rank MSN 1830).

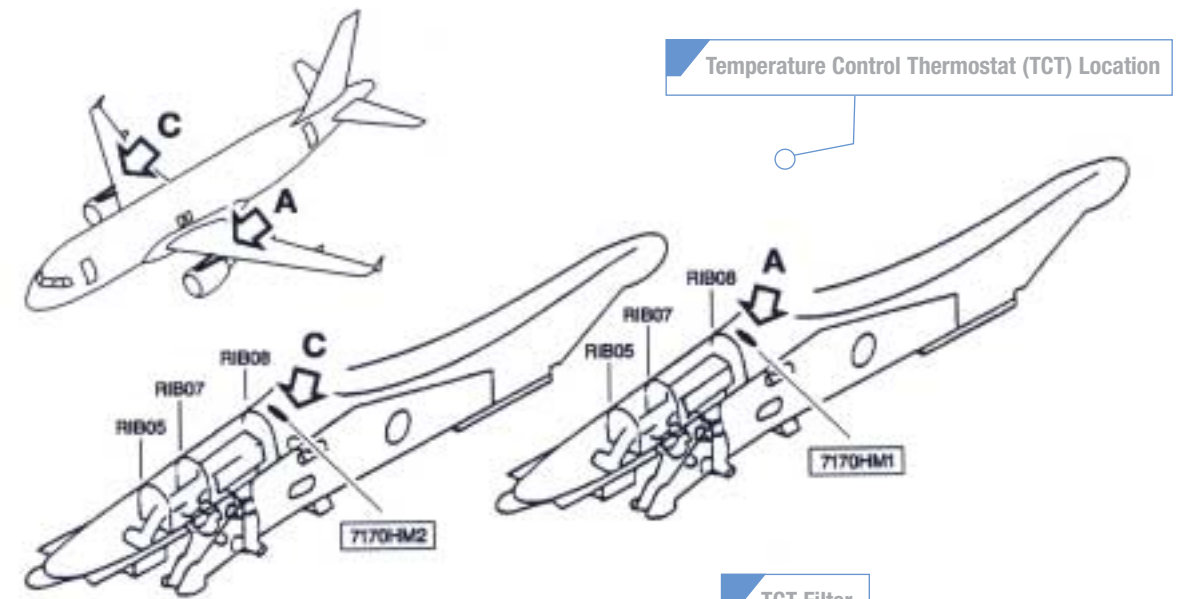
Examples of TCT clogged filters

Another well known possibility for bleed air over-temperature is the TCT filter clogging. To address this issue regular filter cleaning is recommended and is available through the application of the corresponding MPD task. Today's recommended interval is 20 months. Nevertheless, depending on operating environment and operator's experience, a less or a more frequent initial interval may be used. For example, it has been well established that Middle East operators were more affected than others. This recommendation is also described in SIL 36-055.
