### SERVICE BULLETIN

### SIAT223-SB-001/19

Überprüfung Lagerbolzen Landeklappe  
links und rechts

Inspection of bearing bolt on R/H and L/H  
flap

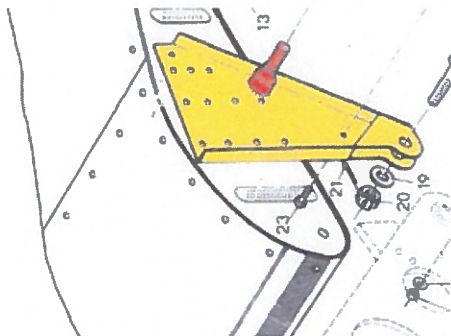
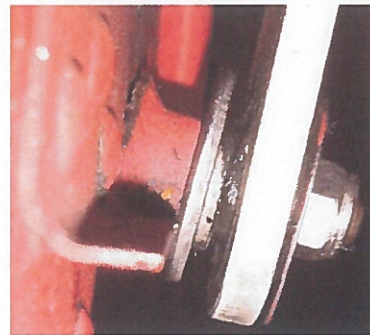
Vorgefundener Riss der Befestigungs-  
schweissnaht (Lagerbolzen / Beschlag)

Bei einer Inspektion wurde ein  
ausgebrochener Lagerbolzen an einer  
Landeklappe vorgefunden (siehe  
Skizze/Foto).

Crack found on weld (bearing bolt / fitting)

A cracked bearing bolt weld was found on  
a flap during an inspection (see sketch /  
photo).

Es sind die Schweißbereiche beider Lagerbolzen an linker und rechter Landeklappen zu reinigen und einer Sichtprüfung zu unterziehen.

The welded areas of both bearing bolts on the L/H and R/H flap have to be cleaned and visually inspected.
