Subject: Tests on the load bearing capacity of shoulders

service
technique
des Bases
aériennes

TESTS ON THE LOAD BEARING CAPACITY OF SHOULDERS

Study report

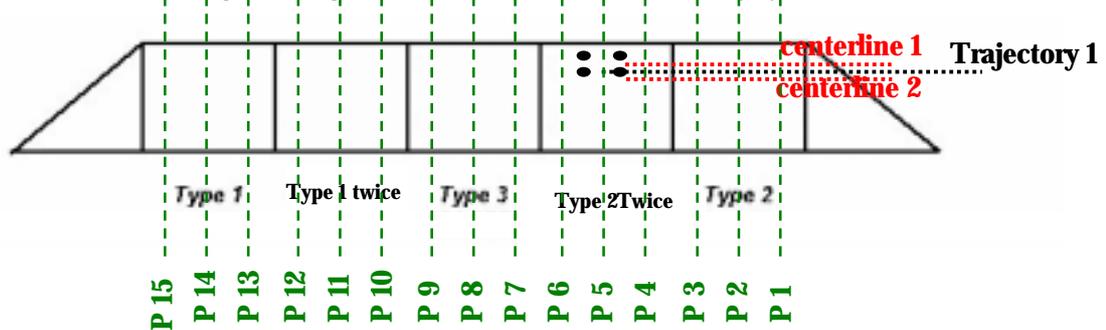
The beginning of test was on 03/07/02 at 9:05 am local time, test stopped at 9:06 am. The bogie sank on the type 2 twice structure. Bogie sinking was sudden and remained relatively symmetrical.

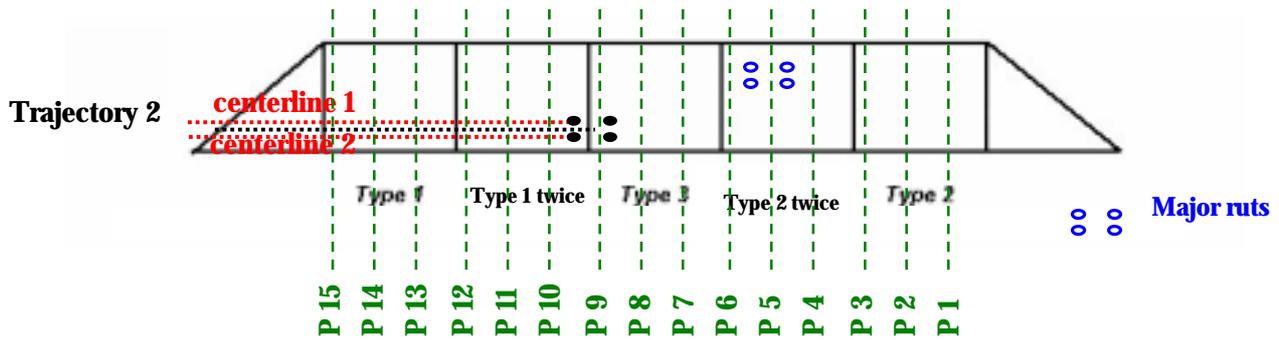
Sinking of the bogie was very sudden and was highly asymmetrical, which suggested there was a lateral variation in the subgrade strength under the two bogies tyre center lines of subgrade contact.

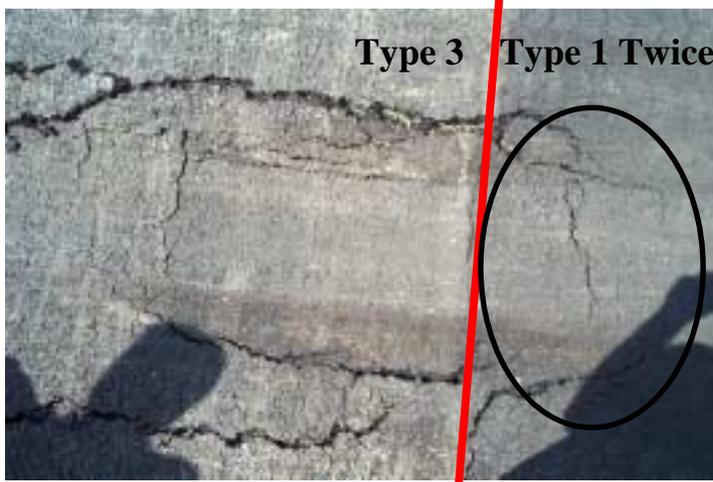
In fact, the analysis of the load bearing capacity (refer to paragraph « Preliminary Results ») reveals that the rupture zone is precisely located on the weakest point recorded on the base (zone at 10.7 MPa, which is very weak). This typical weakness of the base subgrade even partly extends to type 1 twice section:

It was found that the subgrade type 3 induced damage to the GLSR course causing rupture of surface material in section type 1 twice. This certainly explains the different observations made for the type 1 twice section between profiles P12 and P11 (highly comparable) and profile P10.

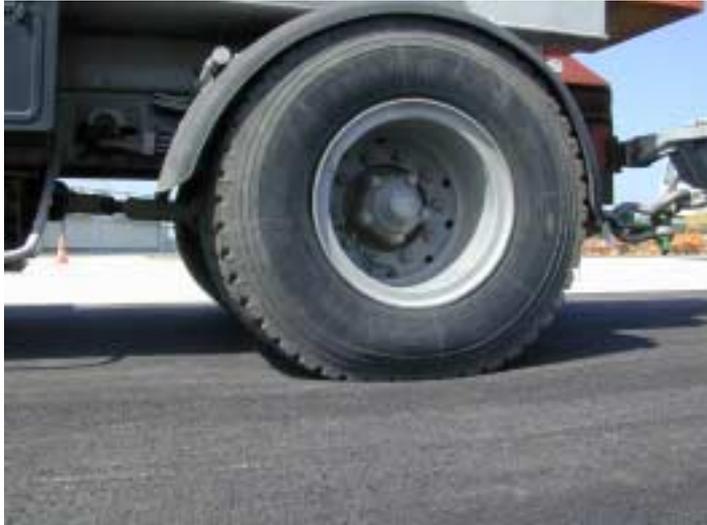
However, these results do not take into account the very high elastic deformation (around one centimeter at least) during rolling of the 2-wheel module on 2 twice and 3 sections, which can even be observed under the rear axle of the truck:

◀ *Picture no. 4: deformation type 3 section under the rear axle of the truck*

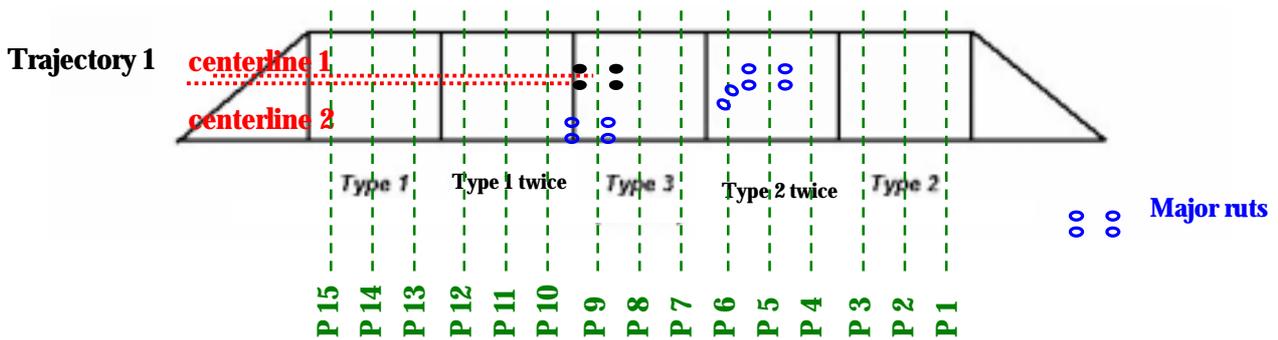
Sinking of the bogie was not as sudden as recorded during test no. 2 on the same section: the footprint in BBME remains relatively symmetrical (comparison of centerlines 1 and 2).

The pavement had not caved in. The truck was not powerful enough to pull out the module from the rut (the test could have been continued if a more powerful truck had been available). The behavior of type 3 section during this test seems to show the capability of BBME to prevent abrupt rupture of the pavement. However, taking into account the weakness of the base at this part of the section (point at 19 MPa on the base course, most certainly explaining partly the deformation of profile P10) it does not enable us to conclude on the occasional rolling capacity of type 3 section.

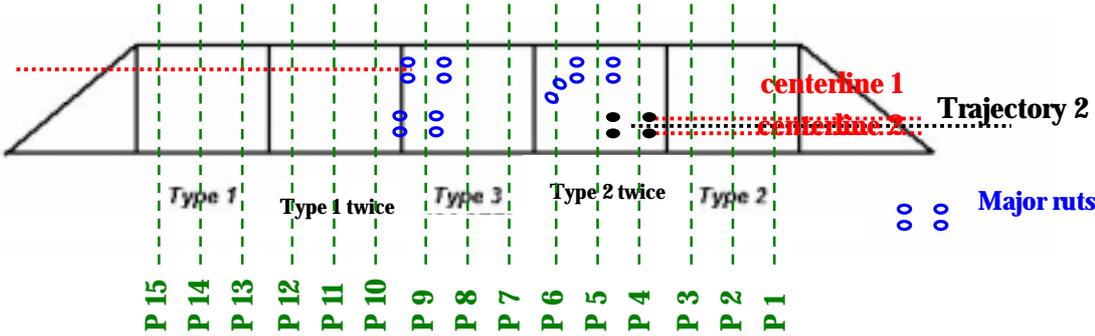
The bogie suddenly sank with a steep depression of tyre 1 centerline while tyre 2 remained at the test surface level. Sinking was entirely asymmetrical (practically no deformation under centerline 2), which may be due to a weakness in the center zone of the base.

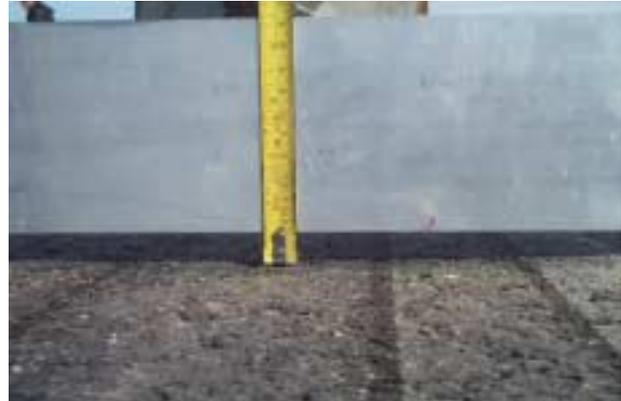
▲ Picture no. 2: rut profile P2 centerline 2

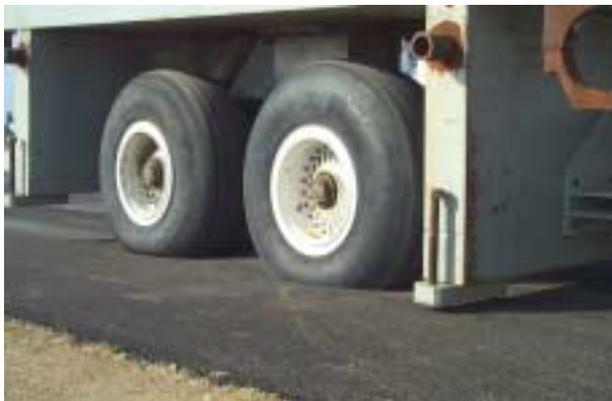
▲ Picture no. 3: bogie sunk in Type 2 twice section

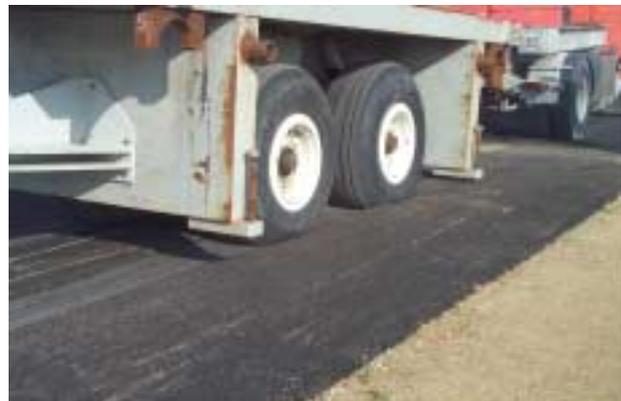
▲ Picture no. 4: bogie sunk in Type 2 twice section, rear view

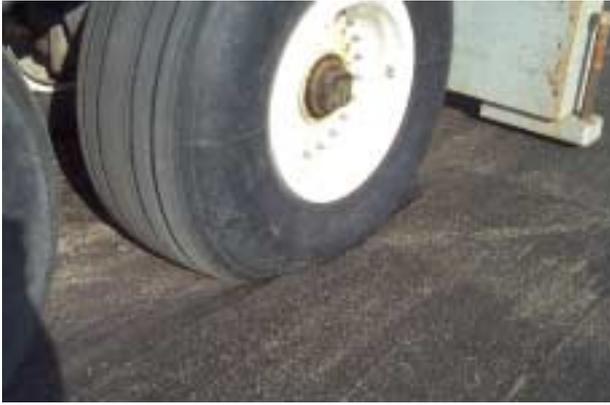
▲ *Picture no. 5: front axle of bogie sunk in Type 2 twice section*

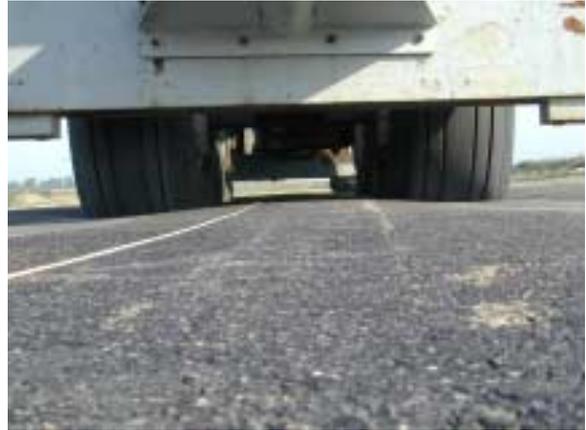
▲ *Picture no. 6: rut Type 2 twice section: symmetry*

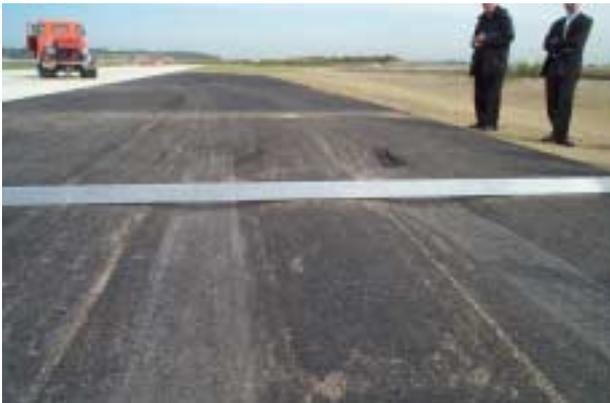
▲ *Picture no. 7: rut Type 2 twice section after removal of the bogie*

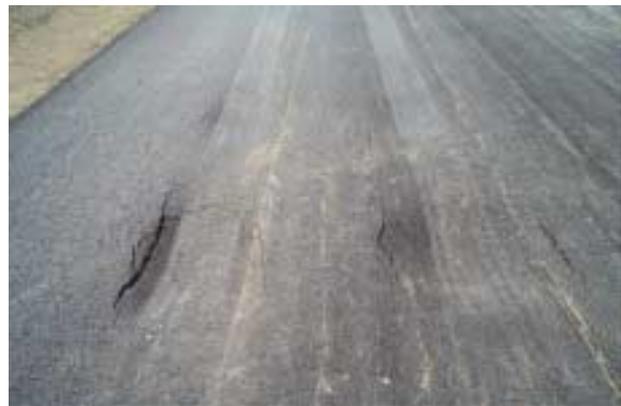
▲ *Picture no. 8: rut Type 2 twice section after removal of the bogie (front axle in foreground)*

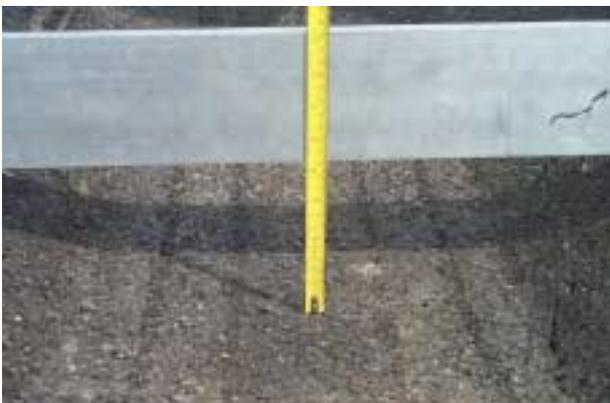
▲ *Picture no. 9: rut Type 2 twice section after removal of the bogie (maximum rut, front axle centerline 2)*

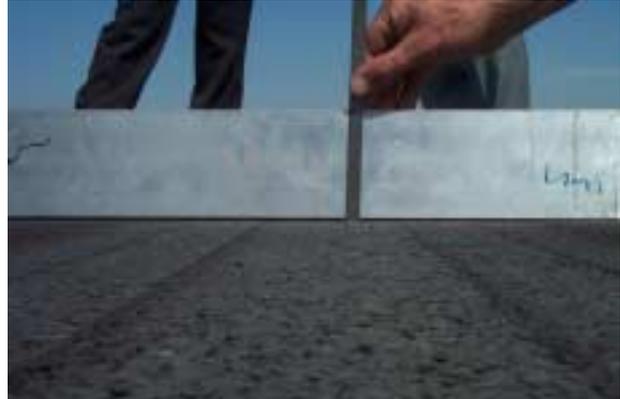
▲ Picture no. 11: Rut profile P12 centerline 1

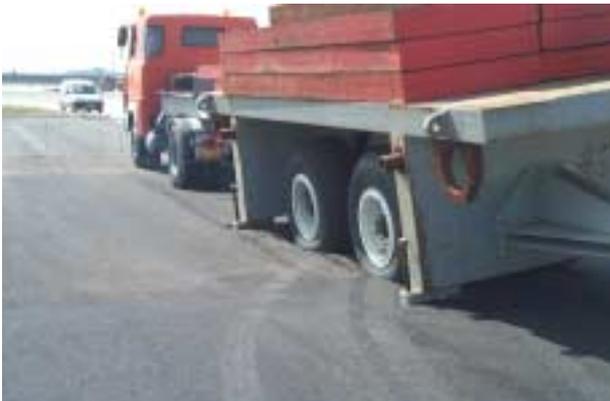
▲ Picture no. 12: bogie sunk in Type 3 section: rear view

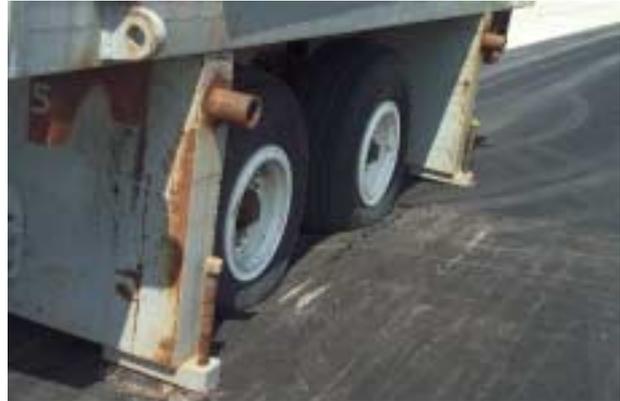
▲ Picture no. 13: bogie sunk in Type 2 twice section

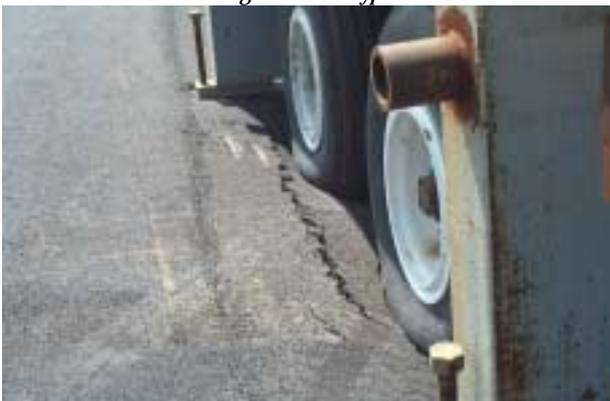
▲ Picture no. 14: centerline 1 of bogie sunk in Type 3 section

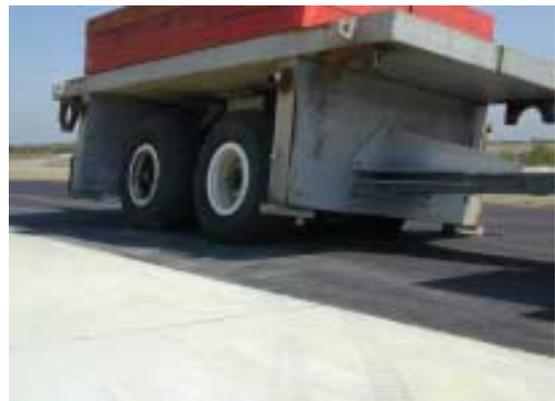
▲ Picture no. 15: view centerline 2 of bogie; no sinking (asymmetry)

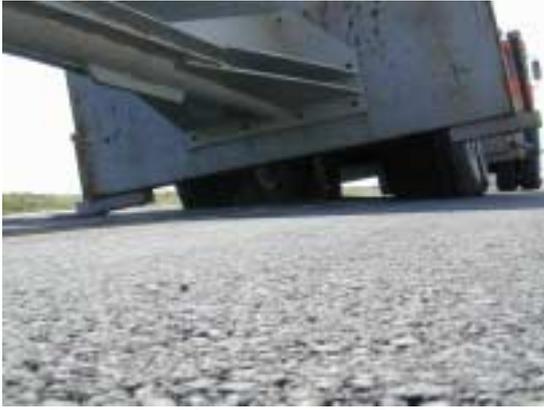
▲ *Picture no. 16: rear view, rut Type 3 section; asymmetry*

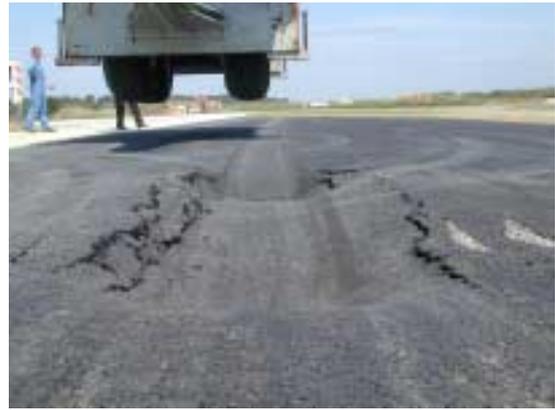
▲ *Picture no. 17: rut Type 3 section after removal of the bogie: view according to centerline 1 (front axle in foreground)*

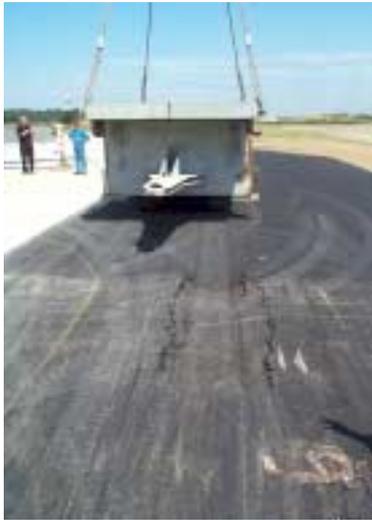
▲ *Picture no. 18: rut Type 3 section after removal of the bogie (front axle in foreground)*

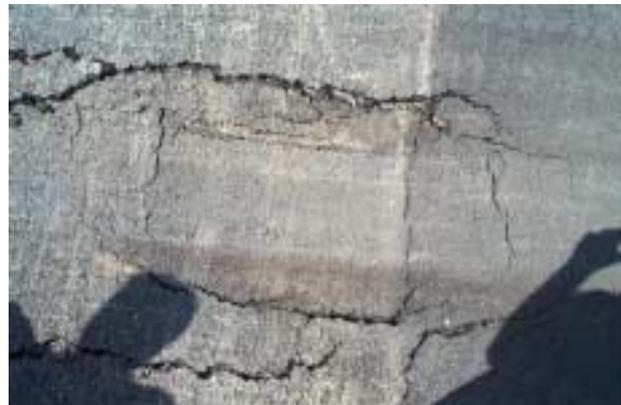
▲ *Picture no. 19: rut Type 3 section after removal of the bogie: view according to centerline 1 rear axle*

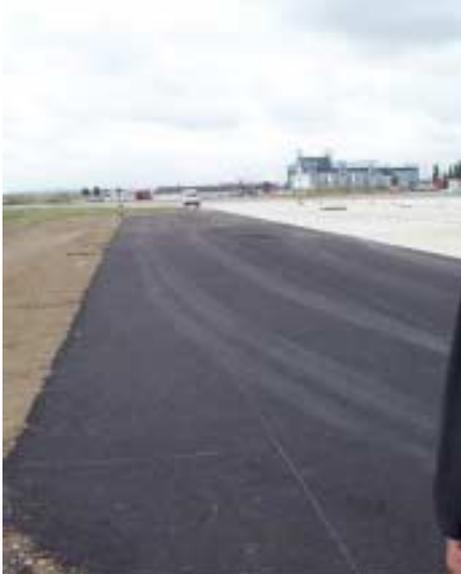
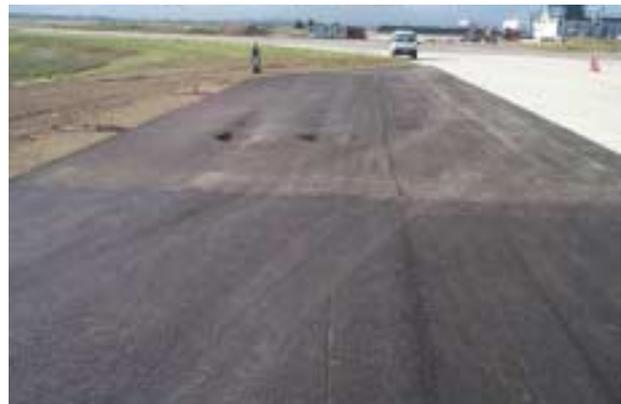
▲ *Picture no. 22: S trajectory, type 3, 2 twice and 2 section (rutting on type 2 twice)*

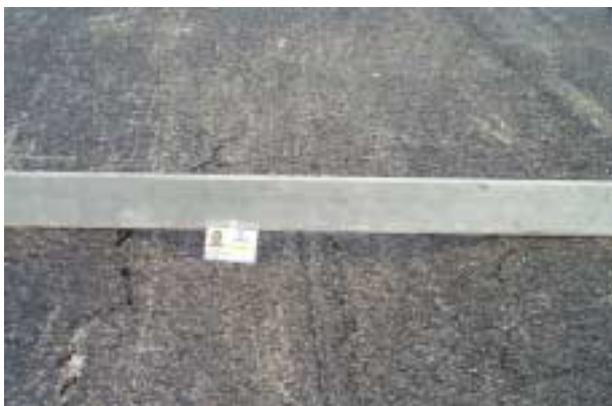
▲ *Picture no. 24: rutting on type 2 twice*

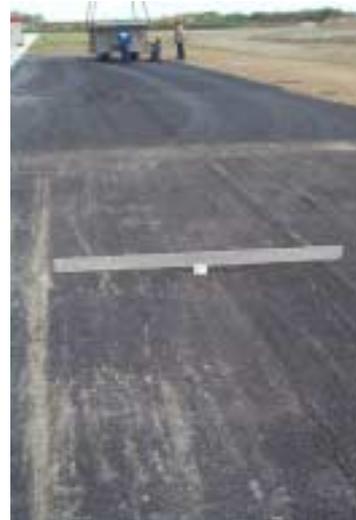
➤ *Picture no. 25: rutting on type 2 twice*

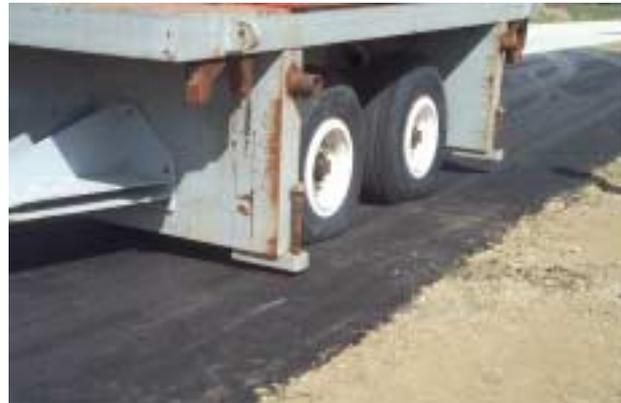
▲ Picture no. 29: bogie sunk in Type 3 section

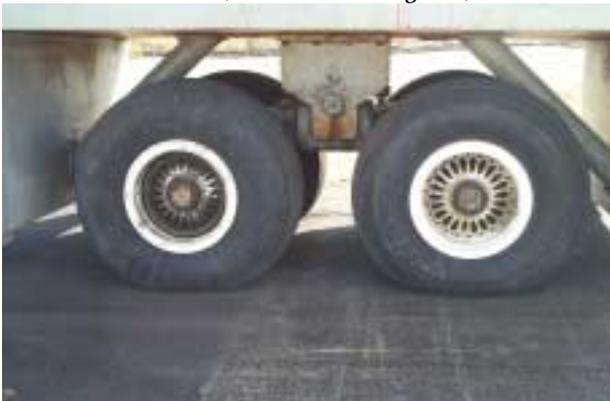
▲ Picture no. 30: bogie sunk in Type 3 section, view centerline 2

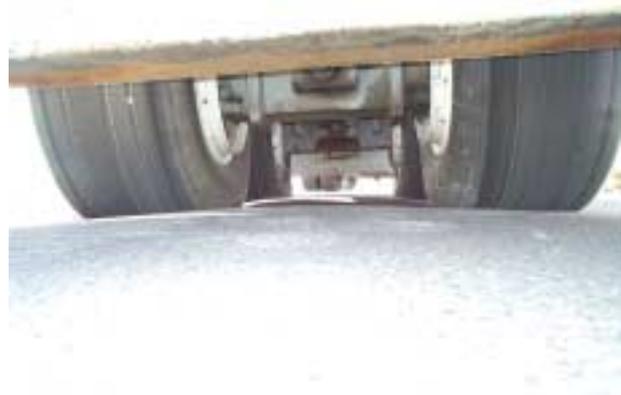
▲ Picture no. 31 rut type 3 section: practically symmetrical

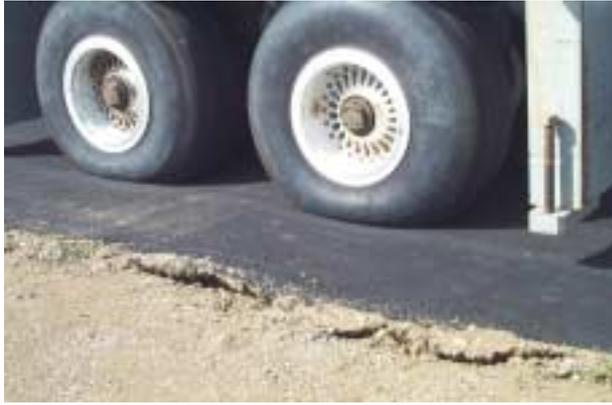
▲ *Picture no. 32: surface material lifting*

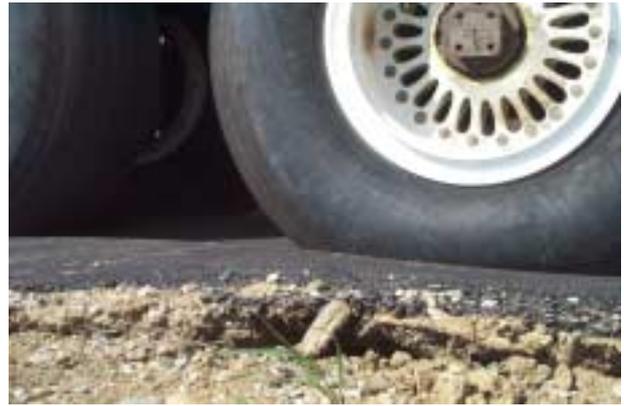
▲ *Picture no. 33: surface material lifting*

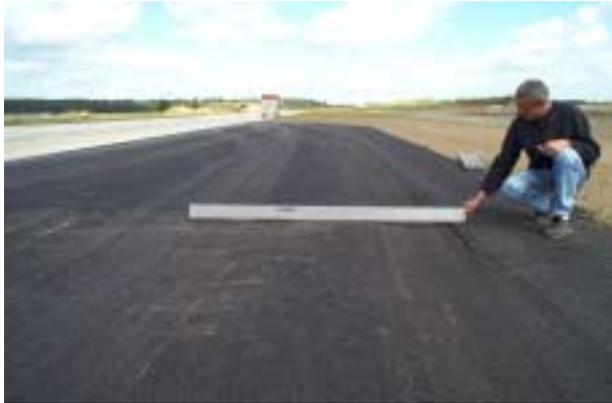
▲ *Picture no. 34: rut Type 3 section after removal of the bogie (front axle in foreground)*

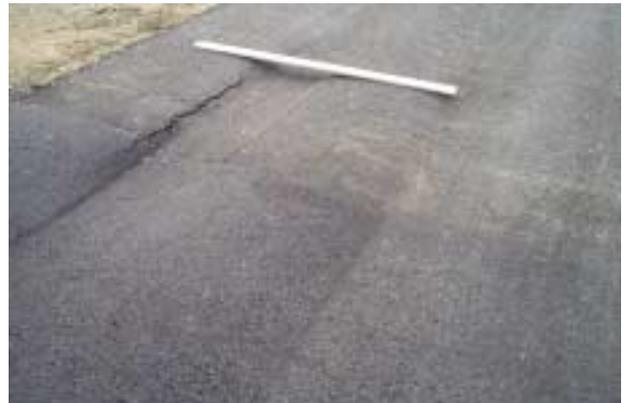
▲ *Picture no. 35: rut Type 3 section after removal of the bogie (rear axle in foreground)*

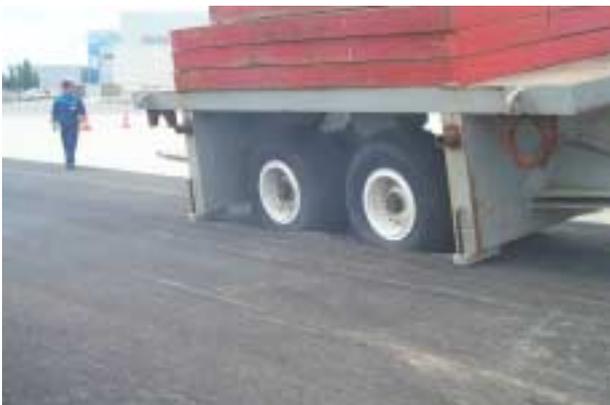
▲ Picture no. 38: bogie sunk in Type 2 twice section: view centerline 1

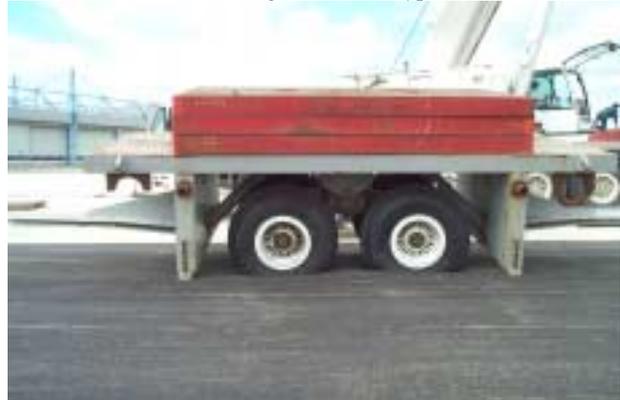
▲ Picture no. 39: bogie sunk in Type 2 twice section: view centerline 1

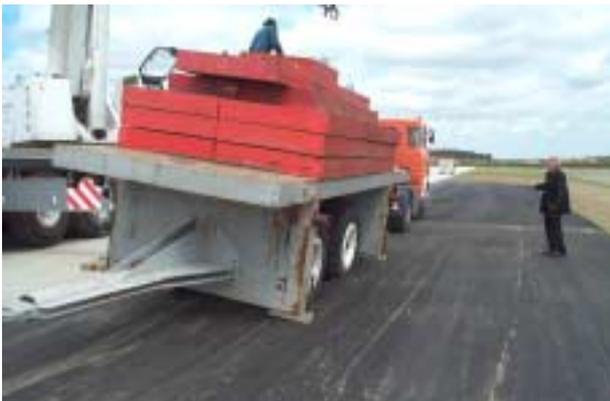
▲ Picture no. 40: bogie sunk in Type 2 twice section: rear view centerline 1

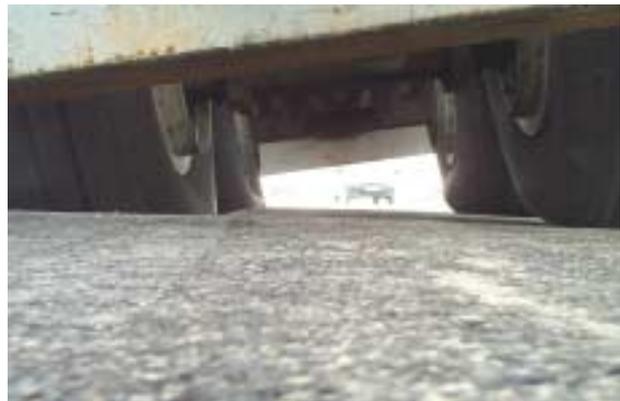
▲ Picture no. 41: rear view rut Type 2 twice section: dissymmetry

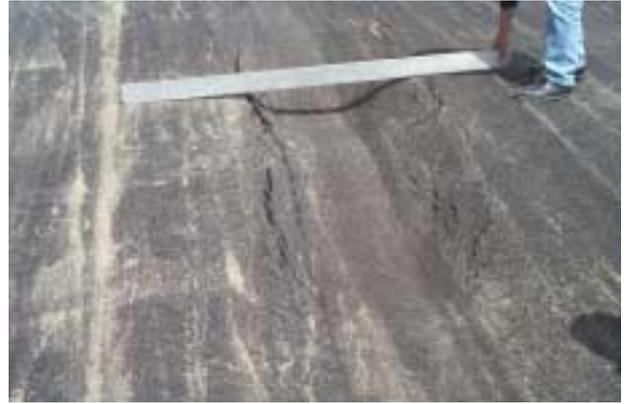
▲ *Picture no. 43: rut under centerline 1 Type 2 twice section after removal of the bogie (rear axle in foreground)*

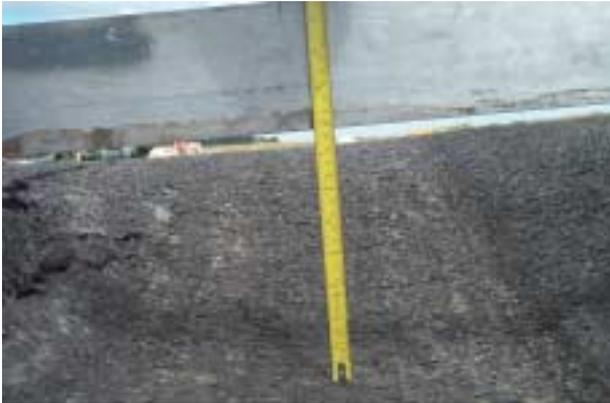
▲ *Picture no. 44: rut under centerline 1 rear axle Type 2 twice section after removal of the bogie*
