Maintenance Briefing Notes Best Practices Ground Support Equipment and Tools

MBN Reference : MAINT – BST_PRAC - SEQ 01 – REV 01 – JAN. 2008

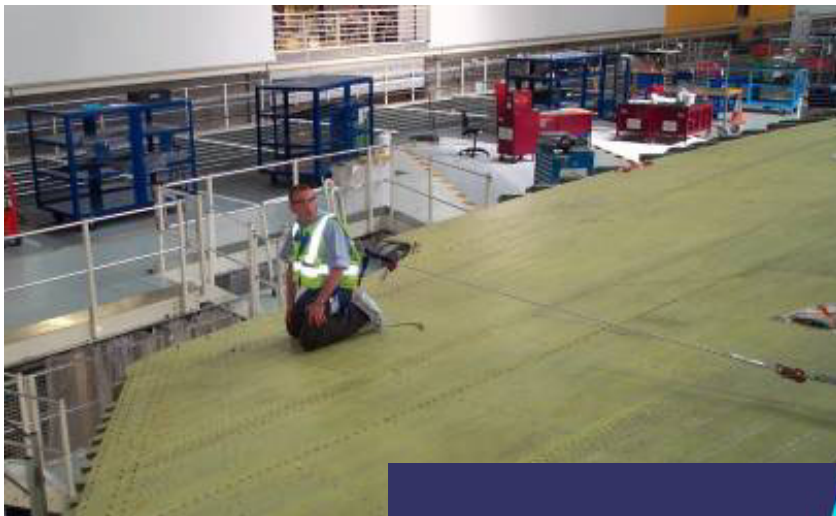
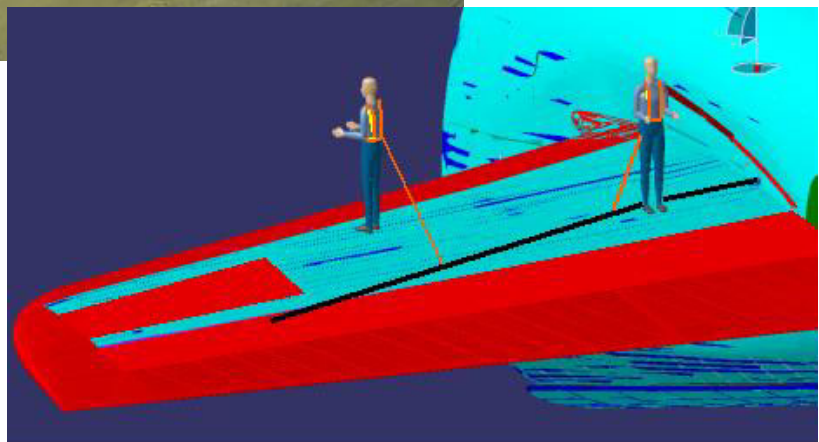
Definition and on-aircraft validation of safety rope provisions, enabling work on the horizontal tail plane

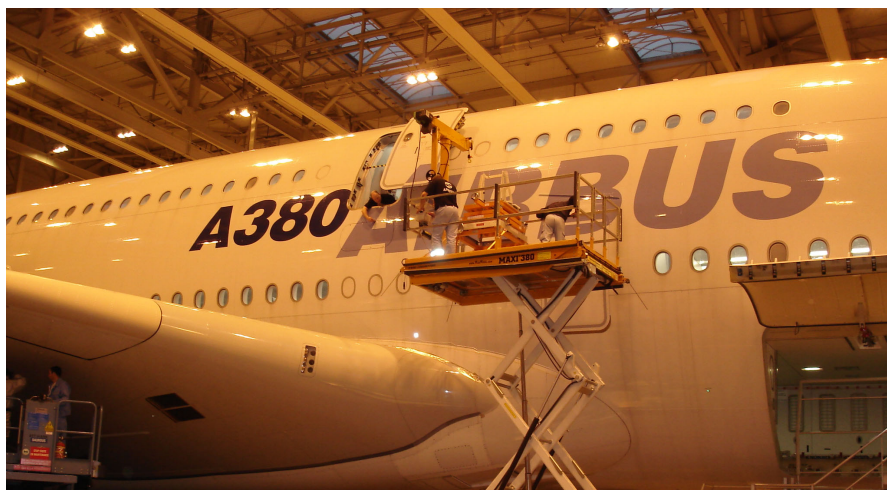
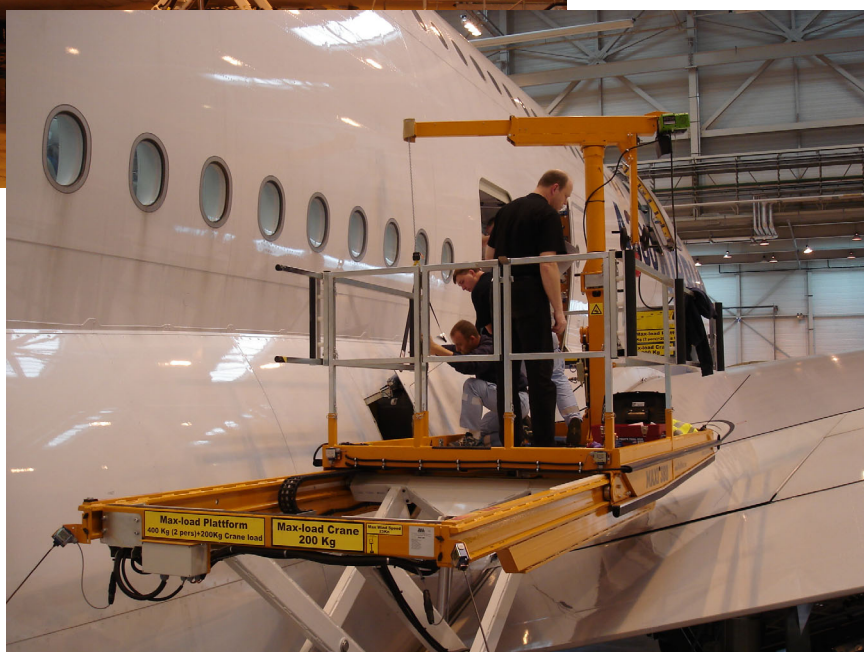
Validation of the upper deck slide raft removal / installation GSE.

Once a new GSE/Tool has been designed, a prototype is then manufactured, and it's use is tested on aircraft under real maintenance conditions. This is to ensure that the tool fulfills its function, evaluate its function vis-a-vis health and safety regulations applicable to its design, and test specific scenarios for maintenance - induced errors.

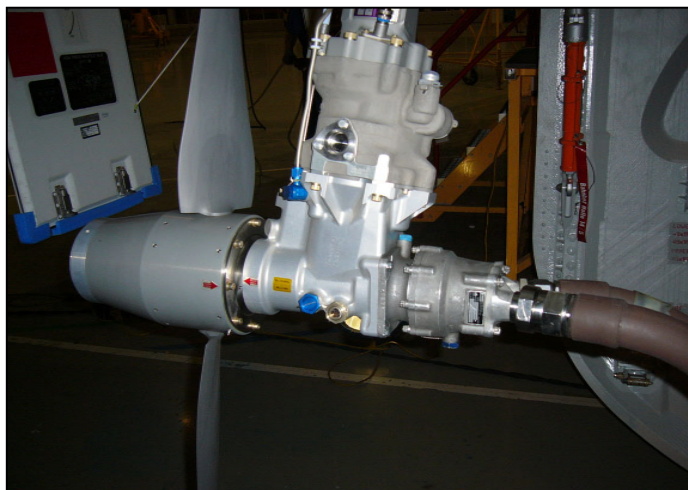
Ground testing of the RAT requires that a hydraulic test motor be attached to the RAT, driving mechanically the RAT once supplied with hydraulic pressure from the hydraulic ground cart.

RAT ground test procedure:

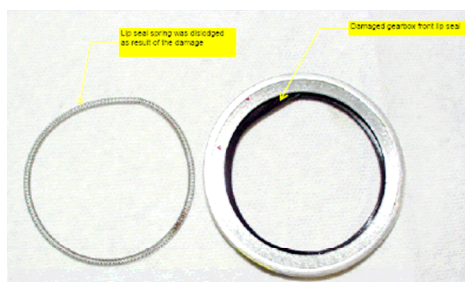
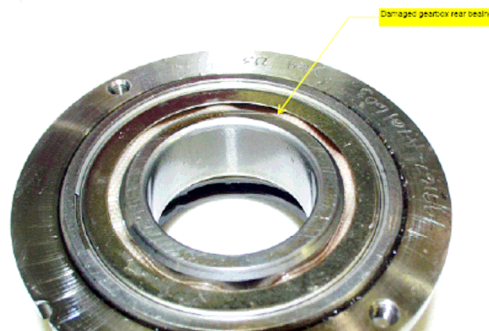
There have been cases where, further to a RAT ground test, a leakage was noticed at the rear side of the RAT, leading to the loss of the gearbox lubricant.

The leakage was caused by a damaged seal at the interface between the test motor and the RAT gearbox.

Such damage is typical of an over-pressurization of the back-drive motor.

An over-pressurization can be induced by either:

- a “kink” in the test motor hydraulic return hose
- a wrong hydraulic ground cart input pressure selection
- a cross-connection of the high pressure and low pressure ports at the level of the test motor.

The high and low pressure hydraulic hoses are normally fixed to the test motor using Loctite as second retention. However, contamination with other products can over time lead to the Loctite being dissolved.

- Check the RAT ground test motor return line for kinks or blockage
- Inspect the RAT gearbox interface for leakages before and after performing the RAT ground test
- Check the RAT gearbox oil level
