Subject: Tests on the load bearing capacity of shoulders

service
technique
des Bases
aériennes

TESTS ON THE LOAD BEARING CAPACITY OF SHOULDERS

Study report

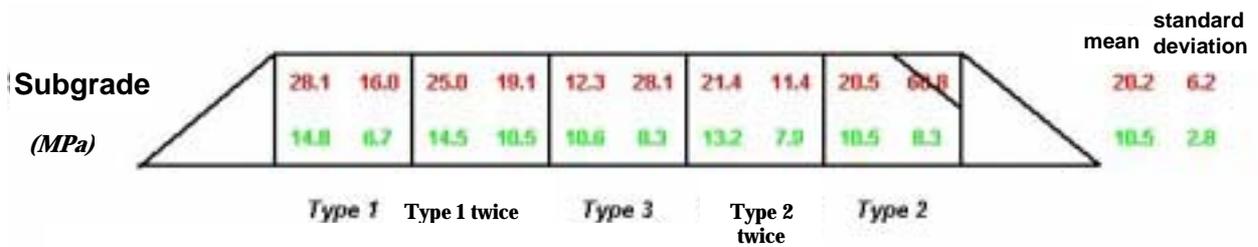
The practical results obtained on the test surfaces showed a much lower load bearing capacity than expected from calculations of the surface design, which had targets of CBR³ 7 and 10. In fact, an average 15.1 MPa value was obtained, corresponding more closely to a 2 or 3 CBR value.

Moreover, the sample is relatively dispersed (standard deviation around 7 MPa). The results showed two distinct area of strength, represented in red and in green on the diagram above which had much less scatter results. The zone corresponding to the green line was effectively excavated more than the other during the construction works (recent) of the adjacent concrete runway (slip form passage, etc.).

Despite these very low values it was decided nevertheless to retain the planned structure for the remainder of the tests. However it was recognized that some test sections (especially type 2 twice) would have obvious structural weaknesses.

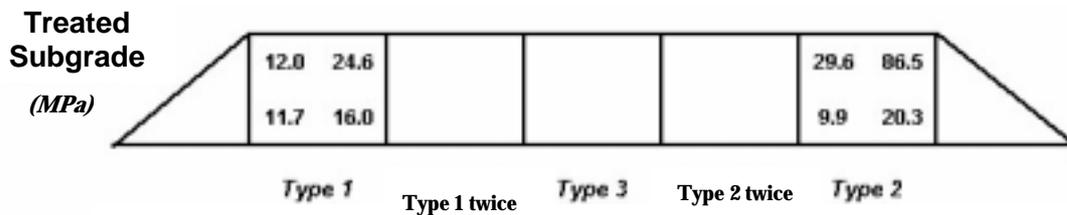
The treatment process was as follows: the soil was first of all extracted, treated then put back in place and compacted. This explains the load bearing capacity drop after treatment (comparison between points 10.7 not treated and 9.9 treated). Moreover, the measurements indicated above are very short-term measurements (D+1). However, the load bearing capacity of treated subgrade increases significantly in the long term.

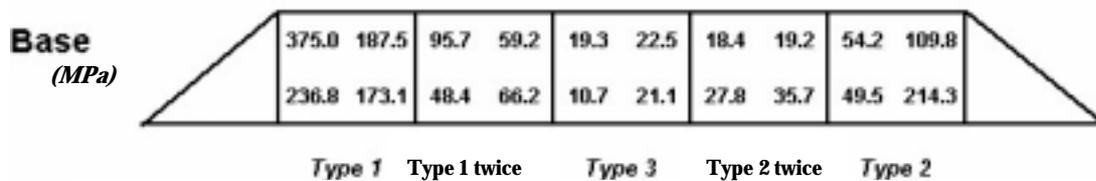
Measurements above reveal a relatively wide dispersion of values for GLSR base courses (Type 1 and Type 1 twice), as well as for the GRH base course on treated subgrade (Type 2). On the other hand, results are more homogeneous on the GRH base course on untreated subgrade (Type 2 twice and Type 3). Also, a zone weaker than the others (10.7 MPa) is found.

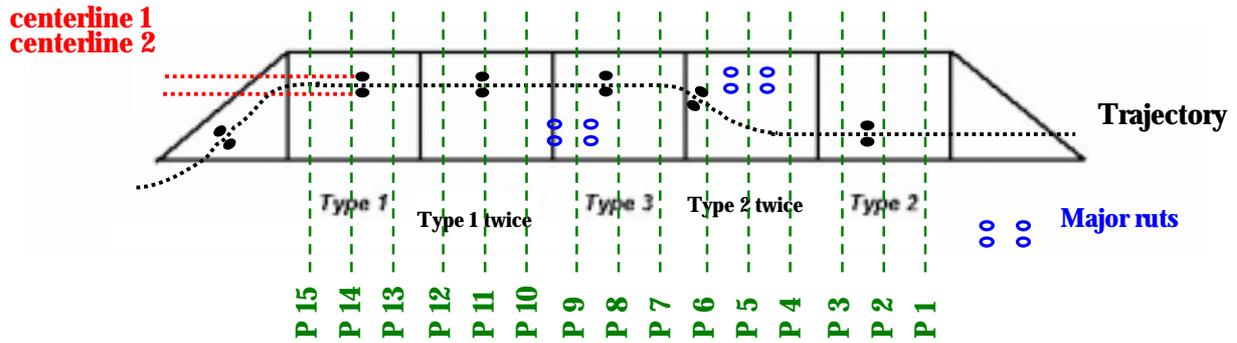
The rut depth measurement results are :

Centerline 1	Centerline 2
Type 1	P15	0 mm	0 mm
	P14	0 mm	0 mm
	P13	0 mm	0 mm
Type 1 twice	P12	2 mm	0 mm
	P11	2 mm	0 mm
	P10	2 mm	0 mm
Type 3	P9	7 mm	15 mm
	P8	6 mm	8 mm
	P7	12 mm	12 mm
Type 2 twice	P6	30 mm	10 mm
	P5	58 mm	18 mm
	P4	24 mm	8 mm
Type 2	P3	6 mm	NM ⁶
	P2	6 mm	NM
	P1	3 mm	NM

Therefore, relatively good shoulder resistance was found.

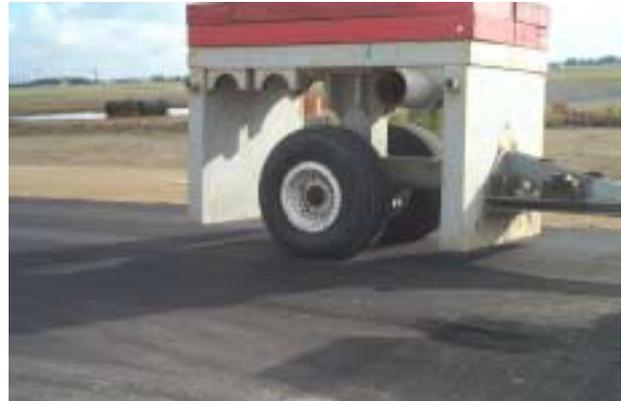
▲ *Picture no. 21: rolling of 2-wheel module on type 1 twice section*

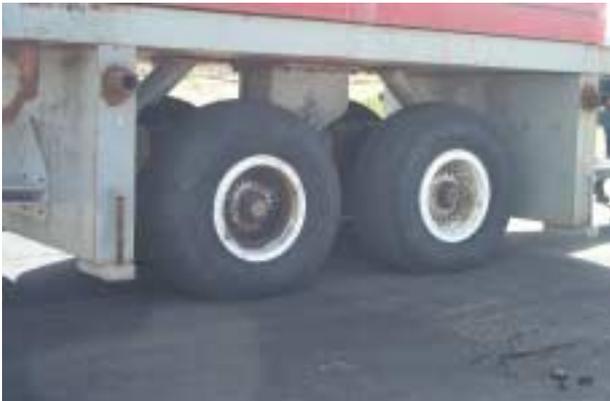
▲ Picture no. 28: rolling test no. 5, transition type 1 twice and type 3 section (rut test no. 2 in foreground)

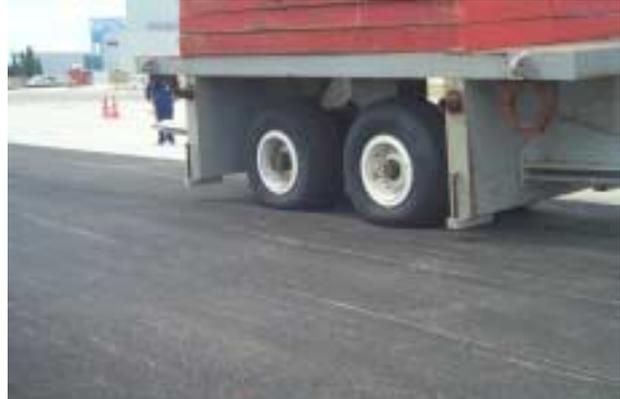
- type 2 section: acceptable for experimental conditions and therefore suitable for operational conditions (with a definite requirement to plan repair works of the shoulder following runway excursion and/or immobilization of a heavy aircraft on the shoulder).

▲ Picture no. 37: rolling test no. 6: type 2 section

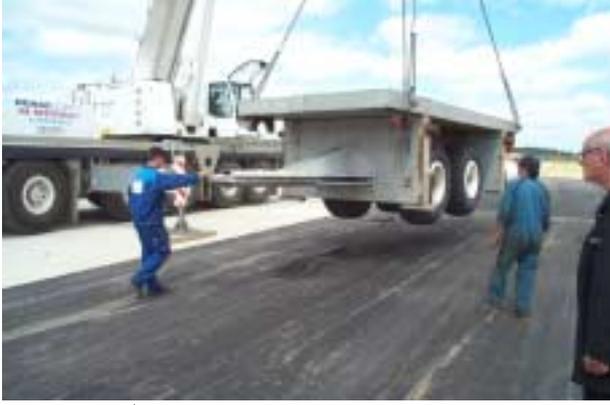
▲ *Picture no. 42: removal of bogie*
